## Kinematics of the 1991 Randa rockslides (Valais, Switzerland)

M. Sartori, F. Baillifard, M. Jaboyedoff, J.-D. Rouiller

M. Sartori, F. Baillifard, M. Jaboyedoff, J.-D. Rouiller. Kinematics of the 1991 Randa rockslides (Valais, Switzerland). *Natural Hazards and Earth System Science*, 2003, 3 (5), pp.423-433. <hal-00299051>

**Abstract.** About 22 mio m<sup>3</sup> of rock fell from a cliff near the village of Randa (10 km north of Zermatt, Switzerland) on 18 April 1991. A second retrogressive rockslide of about 7 mio m<sup>3</sup> followed on 9 May 1991. At present, a rock mass situated above the scarp is still slowly moving toward the valley, involving several mio m<sup>3</sup> of rock.

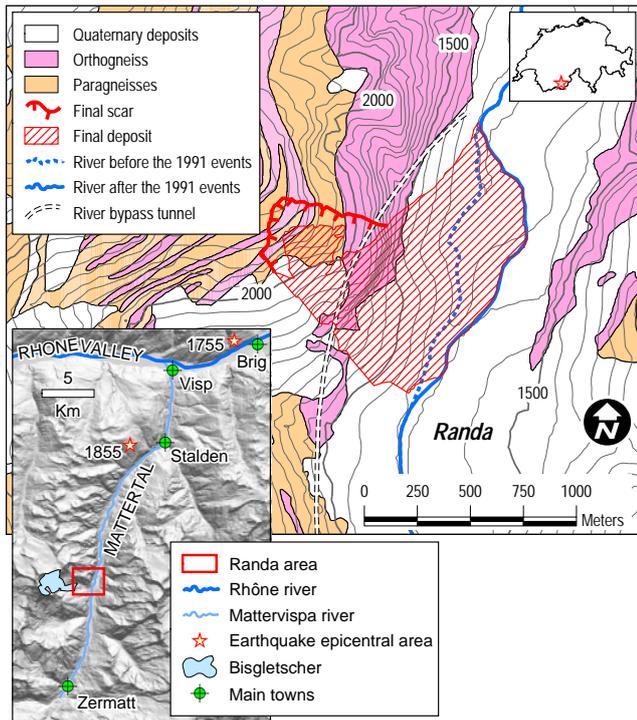
**Fig. 1.** Hillshade of the Mattertal (data: SWISSTOPO) and epicentral location of the 1755 and 1855 earthquakes (data: Ecos, Swiss Seismological Service), location of the Randa rockslides and simplified geological map (after Bearth, 1964).

Several perched glacial cirques notch the western wall of the Mattertal. Generally, rock outcrops located downstream of the confluence between the tributaries and the main valley present two characteristics: (1) these mountain flanks underwent especially high confining pressures due to the joining of two glaciers during the glacial periods, as well as high decompression processes during late- to post-glacial periods, and (2) the range of slope orientations is wider in such outcrops than on a single valley’s wall, increasing the number of potential sliding surfaces on pre-existing discontinuities. The Randa unstable area is located on a ridge formed by the intersection of the Mattertal main valley and the Bisgletscher glacial cirque (Fig. 1).

The lithology controls the steepness of the western wall of the Mattertal (Fig. 1): the Randa orthogneiss is a Permian porphyritic granite intruded as a pseudo-laccolith within the Pre-Permian paragneisses and the Permian metagreywackes of the Siviez-Mischabel nappe (Bearth, 1964; Thélin, 1987).

northeast of Randa; estimated magnitude: 6.1) and 1855 (epicentral location: Visp-Stalden, 10–20 km north of Randa; estimated magnitude: 6.4) (Fig. 1) (data: Ecos, Swiss Seismological Service, <http://seismo.ethz.ch>). Historical chronicles confirm that many rockfalls occurred throughout the Matternal during and immediately after the 1855 earthquake (Lenoir, 1949). Triggering effects of such energetic seismic waves on rock bridges are certain. Vertical accelerations seem to promote the formation of composite gliding surfaces by connecting adjacent joints; for example, vertical acceleration could have weakened the future failure surface for the 9 May rockslide.

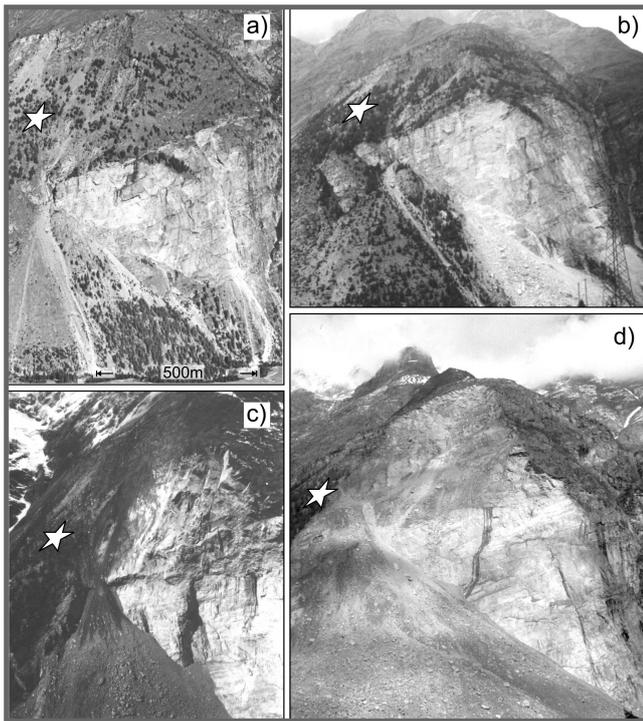
**Fig. 2.** Evolution of the Randa valley wall through time. The vertical cliff consists of orthogneiss, the uppermost dark slopes of paragneisses. Star: reference mark. (a) 1930 (photograph: SWISSTOPO, 1930). (b) 1984 (photograph: Swiss Army, 1984). (c) After the 18 April rockslide (photograph: Swiss Army, 1991). (d) After the 9 May rockslide (photograph: M. Sartori, 1992).

Until the beginning of the 20<sup>th</sup> century, on the oldest available photographs, except for these superficial phenomena, only a few signs of activity within the perimeter of the future 1991 rockslide are detectable. At the middle of the near-vertical Randa orthogneiss cliff, a scarp resulting from the failure of an overhang involving roughly 10 000 m<sup>3</sup> of rock looked relatively fresh in a photography from 1910. At that time, the forest at the foot of the cliff appeared to be moderately impacted by rockfall. On all photographs, the two main single persistent discontinuities can be observed: the J3 basal fault that cut obliquely the base of the wall (Fig. 2a–b) and the J6’ lateral border fracture.

During the middle of the 20th century, increasing rockfall activity affected the northern part of the orthogneiss rock face (Figs. 2 and 7). Further acceleration of activity occurred in 1979, with the fall of some tens of thousands of cubic meters of rocks from the upper middle part of the cliff. Rockfall activity continued, spreading to the entire cliff, with particular intensity on the northern part. As a result, the forest beneath was almost totally destroyed before the 1991 rockslides occurred.

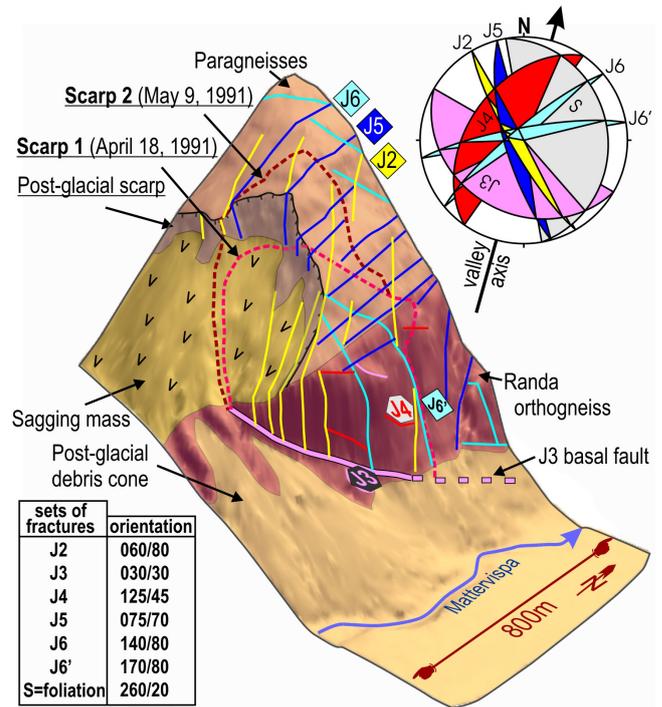
**Fig. 3.** Geomorphological and structural settings of the 1991 Randa rockslides and orientations of the main sets of persistent discontinuities (Schmidt-Lambert stereonet, upper hemisphere). An old rockslide scarp forms the southern flank of the ridge, partly covered by sagging material. The change in the steepness of the slope corresponds with the limit between the orthogneiss and the paragneisses. The most striking structural feature is the basal J3 fault, cutting the base of the cliff. The main persistent fractures are represented. They were used to delimit the rock blocks in the 3-D model.

Identification of persistent fracture lineaments was performed on terrestrial and aerial photographs, and on DTM from before, during, and after the 1991 events (Fig. 3).

The old scarp in the paragneisses and the debris cone mentioned in Sect. 2.5 are of unknown age. This scarp corresponds to one or more rockslide(s), with a total volume estimated at 10 mio m<sup>3</sup>. It is unclear, whether or not a part of the underlying orthogneiss was also involved in a process in which the foot of the wall was removed (“loss of foot” process). These events changed the topography, causing a weakening of the paragneisses ridge and promoting groundwater infiltration within the orthogneiss that forms the foot of this ridge (Fig. 3).

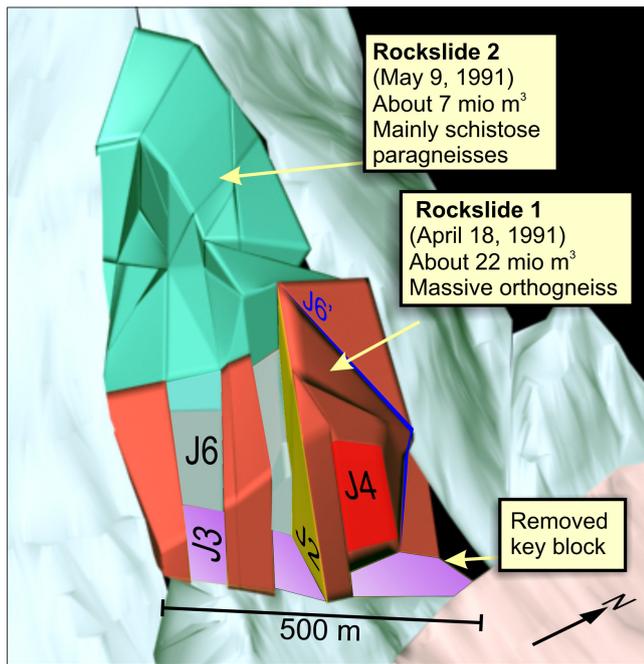
**Fig. 4.** 3-D geometrical model of the 18 April (red) and 9 May 1991 (turquoise blue), unstable masses. Three of the ten rock blocks forming the April failure have been removed for this diagram in order to expose the sliding surfaces (J3, violet; J4, red). The removed block at the lower right side acted as a key block. Due to the high density of fractures, the 9 May unstable mass broke into very small volumes; however, here it has been schematically divided into nine blocks.

The 18 April 1991, rockslide (rockslide 1 in Fig. 4) has been modeled by ten blocks roughly delimited in the Randa orthogneiss with three surfaces: the basal J3 (030/30) surface, the rear near-vertical J6-J6' (155/80) composite system, and the southern J2 (060/80) lateral surface. The southern half of the rock volume is divided by persistent J2 discontinuities, strongly marked on the original rock face (Fig. 2 a–b). Six prismatic blocks, with volumes ranging from 1 to 3 mio m<sup>3</sup> are distinguished. The northern half of the rock mass is dominated by less-persistent J4 discontinuities, that dip southeast. Four blocks are superposed on J4 basal surfaces. The lowest (i.e. “foot”) block of the northern part lays on the J3 basal fault, and hereafter will be referred to as the “key block” (Goodman and Shi, 1985).

The 9 May 1991, rockslide (rockslide 2 in Fig. 4) cut the paragneisses ridge with a complex geometry. The striking feature was a wide basal slip surface, now hidden by debris

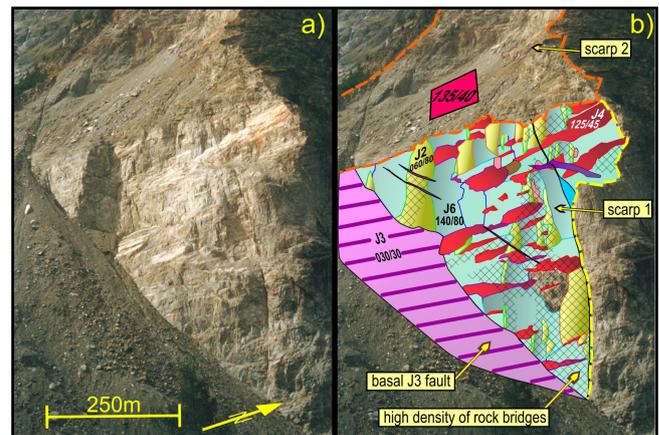
**Fig. 5.** (a) Lower part of the scarp of the Randa rockslides after the 18 April and 9 May 1991, events. (b) Structural interpretation of Fig. 5(a): this part of the scarp, untouched by the second stage (9 May) event, exposes the detachment (blue, J6) and sliding (red, J4) surfaces of the 18 April failure. The basal sliding surface (violet, J3) is hidden by the debris cone. The roughness of these surfaces, tentatively correlated with the density of fractured rock bridges, is clearly higher on the lower right (northern) side of the scarp, and highlights the key status of this rock block. The sliding surface of the second stage of the rockslide, also hidden by scree, appears in the upper part of the photograph (photograph: J.-D. Rouiller, 1991).

(Fig. 5, upper part), oriented 135/40, thus similar to the J4 discontinuity set, but probably consisting of a complex fracture relay system. An arch-shaped scarp was limited to the rear of the rock volume lying on this basal surface. Its southern side consisted mainly of a moderately dipping J2-like orientated surface. The head and the northern side of the scarp were composite surfaces due to traction on the highly fractured paragneisses. Nine blocks have been distinguished in this second-stage mass, divided by persistent joints observed on the original topography. Because of the density of fractures, the reliability of this model is less pertinent than the one of the 18 April rockslide.

We made a qualitative estimate of the roughness of the detachment and sliding surfaces exposed at the scarp (Fig. 5). If this criterion can be correlated with the importance of the fracturing of rock bridges between pre-existing fractures, it clearly illustrates that the northern side of the unstable rock mass may have acted as a key block.

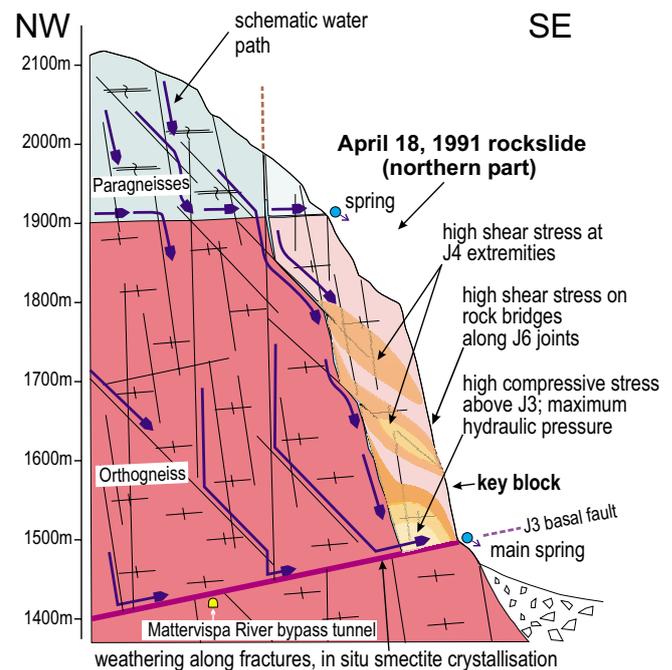
**Fig. 6.** Geological cross section through the northern part of the 18 April 1991, scarp with both hydrogeological and dynamic interpretations. The J3 fault constitutes the basal sliding surface, despite its apparent re-entrant orientation in this section. This fault, sealed with clay minerals due to weathering, acts as an aquiclude. Temporary flow utilizes the fissure network, in particular the open J2 fractures that are behind the unstable mass. The lithological contact is a permeability boundary. This section intersects the key block of the entire structure. There are high stress concentrations at the base of the unstable mass, on J4 extremities and on vertical shear zones parallel to the section. Periods of high water pressure have promoted fracturing within these rock masses.

Within the orthogneiss fractures, water circulation promoted mineralogical alteration, as noted by observations in the Mattervispa River bypass tunnel (Figs. 1 and 6) (Girod, 1999). Some of the draining faults were filled with gouge affected by in situ alteration and precipitation of smectite minerals. A very low angle of internal friction can therefore be postulated for the sliding surfaces of the 18 April rockslide, especially for the basal J3 fault.

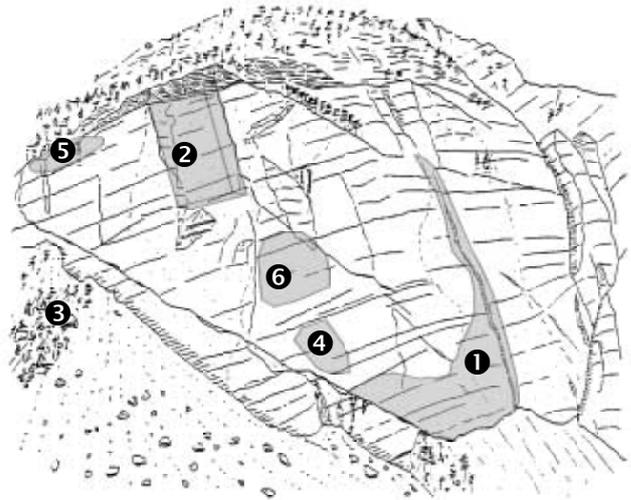
**Fig. 7.** Location of precursory events within the orthogneiss rock face (1970–1991), (modified from Schindler et al., 1993). A 20-year period of increasing rockfall activity culminated on the day before the 18 April rockslide with the explosion-like failure of rock slabs and sprays of water under pressure above the main spring. 1) 1970–1991. 2) 1979. 3) Forest destruction: 1979–1991. 4) 17 April 1991. 5–6) 18 April, before the final failure.

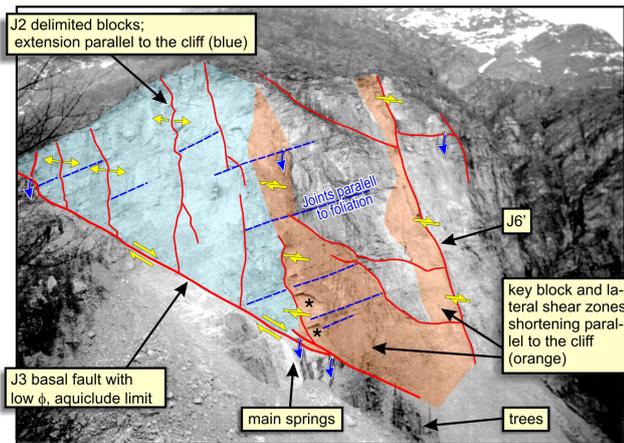
**Fig. 8.** Photograph of the orthogneiss wall on the evening before the 18 April rockslide. The apparent structures, springs, and zones of ongoing fracturing are interpreted in terms of strain. The key block at the lower right part of the unstable mass (orange coloured) underwent shortening and expulsion along two vertical shear zones. Explosion-like failure of rock slabs had already occurred in the southern shear zone, above the main springs (stars). The prismatic blocks at the upper left part of the unstable mass (blue coloured) underwent extension parallel to the direction of the cliff, with opening of the J2 discontinuities. The springs are situated mainly along the intersection between the draining J2 fractures and the sealed J3 basal fault (photograph: Y. Dupertuis, 1991).

The fracturing effects produced by water pressures had been observed since the day before the 18 April rockslide (Schindler et al., 1993) (Fig. 8). Three rock slabs thousands of  $\text{m}^3$  in volume were ejected in turn above the zone of the main springs, along a vertical trend corresponding to the southern sheared limit of the key block. These explosion-like fracturing events were followed by water sprays, suggesting an hydraulic fracturing component. The fall of the upper rock slab occurred 10 min before expulsion of the key block and final collapse of the valley wall.

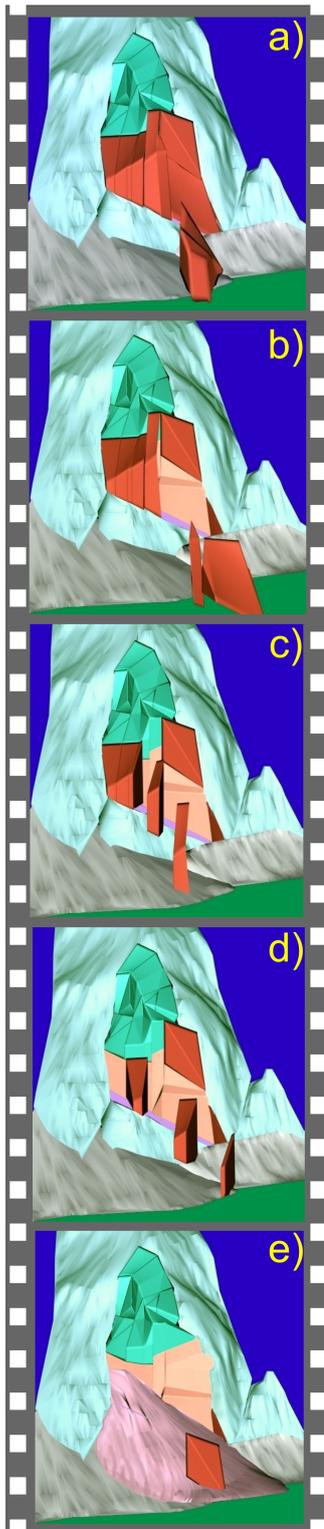
**Fig. 9.** Time-dependent 3-D model of the 18 April 1991, Randa rockslide. **(a)** 18 April, 06:30 am to 07:00 am: expulsion and breaking off of the key block (volume approximately 5 mio m<sup>3</sup>). **(b)** Sliding of the superposed blocks on J4 discontinuities (volume approximately 5 mio m<sup>3</sup>). **(c)–(e)** 07:00 am to 10:00 am: progressive failure of the southern prismatic blocks, sliding on the J3 basal fracture (violet) (volume approximately 10 mio m<sup>3</sup>), and finally failure of the uppermost right corner (e, volume approximately 0.5 mio m<sup>3</sup>).

The southern large prismatic blocks temporarily remained upright without the support of a buttress. They then failed in turn during an ensuing one-hour period (Fig. 9c–e). Sliding of the rock prisms along the basal J3 discontinuity and “foot failure” seem to have been the two most efficient mechanisms for this estimated  $12 \text{ mio m}^3$  part of the rockslide. Volumes of paragneisses were also removed from the crown of the slide, including part of the ancient sagging mass, which caused an increase in the volume of dust. A later minor event occurred on 22 April.

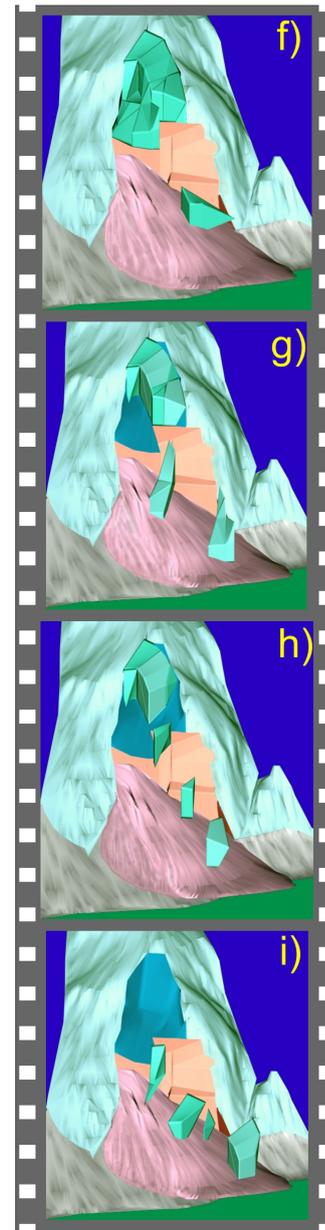
**Fig. 10.** Time-dependent 3-D model of the 9 May 1991, Randa rockslide. **(f)–(i)** 9 May, 06:30 pm to 09:00 pm: progressive failure of the broken up paragneisses mass (volume approximately 7 mio m<sup>3</sup>) on a sliding surface **(f)–(g)** and detachment from the arch-shaped crown **(h)–(i)**.

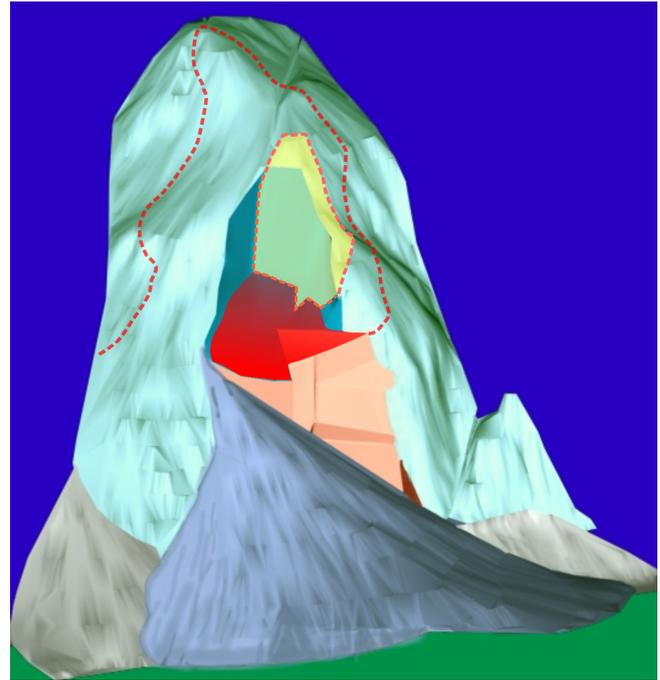
**Fig. 11.** Present day instability (yellow contouring) at Randa. The sliding surface of the 9 May rockslide (red) is probably involved in today's mechanism of slow sliding. This surface has been extrapolated to intersect the ground surface (red contouring), delimiting the long-term retrogressive potential of the unstable mass.

retrogressive erosion process by propagation of the slope failure mechanism along the ridge of paragneisses. The geodetic displacement field is compatible with a sliding mechanism in the dip direction of the pseudo-J4 surface, which acted during the 9 May rockslide (Fig. 11).
